Commonwealth of Kentucky
Environmental and Public Protection Cabinet

Office of Mine Safety and Licensing
P.O. Box 2244
Frankfort, Kentucky 40602
Telephone: (502) 573 - 0140

EMERGENCY AWARENESS BULLETIN

EAB-06008 Kentucky Fatal No.12 (Nationally # 35) Highwall Failure

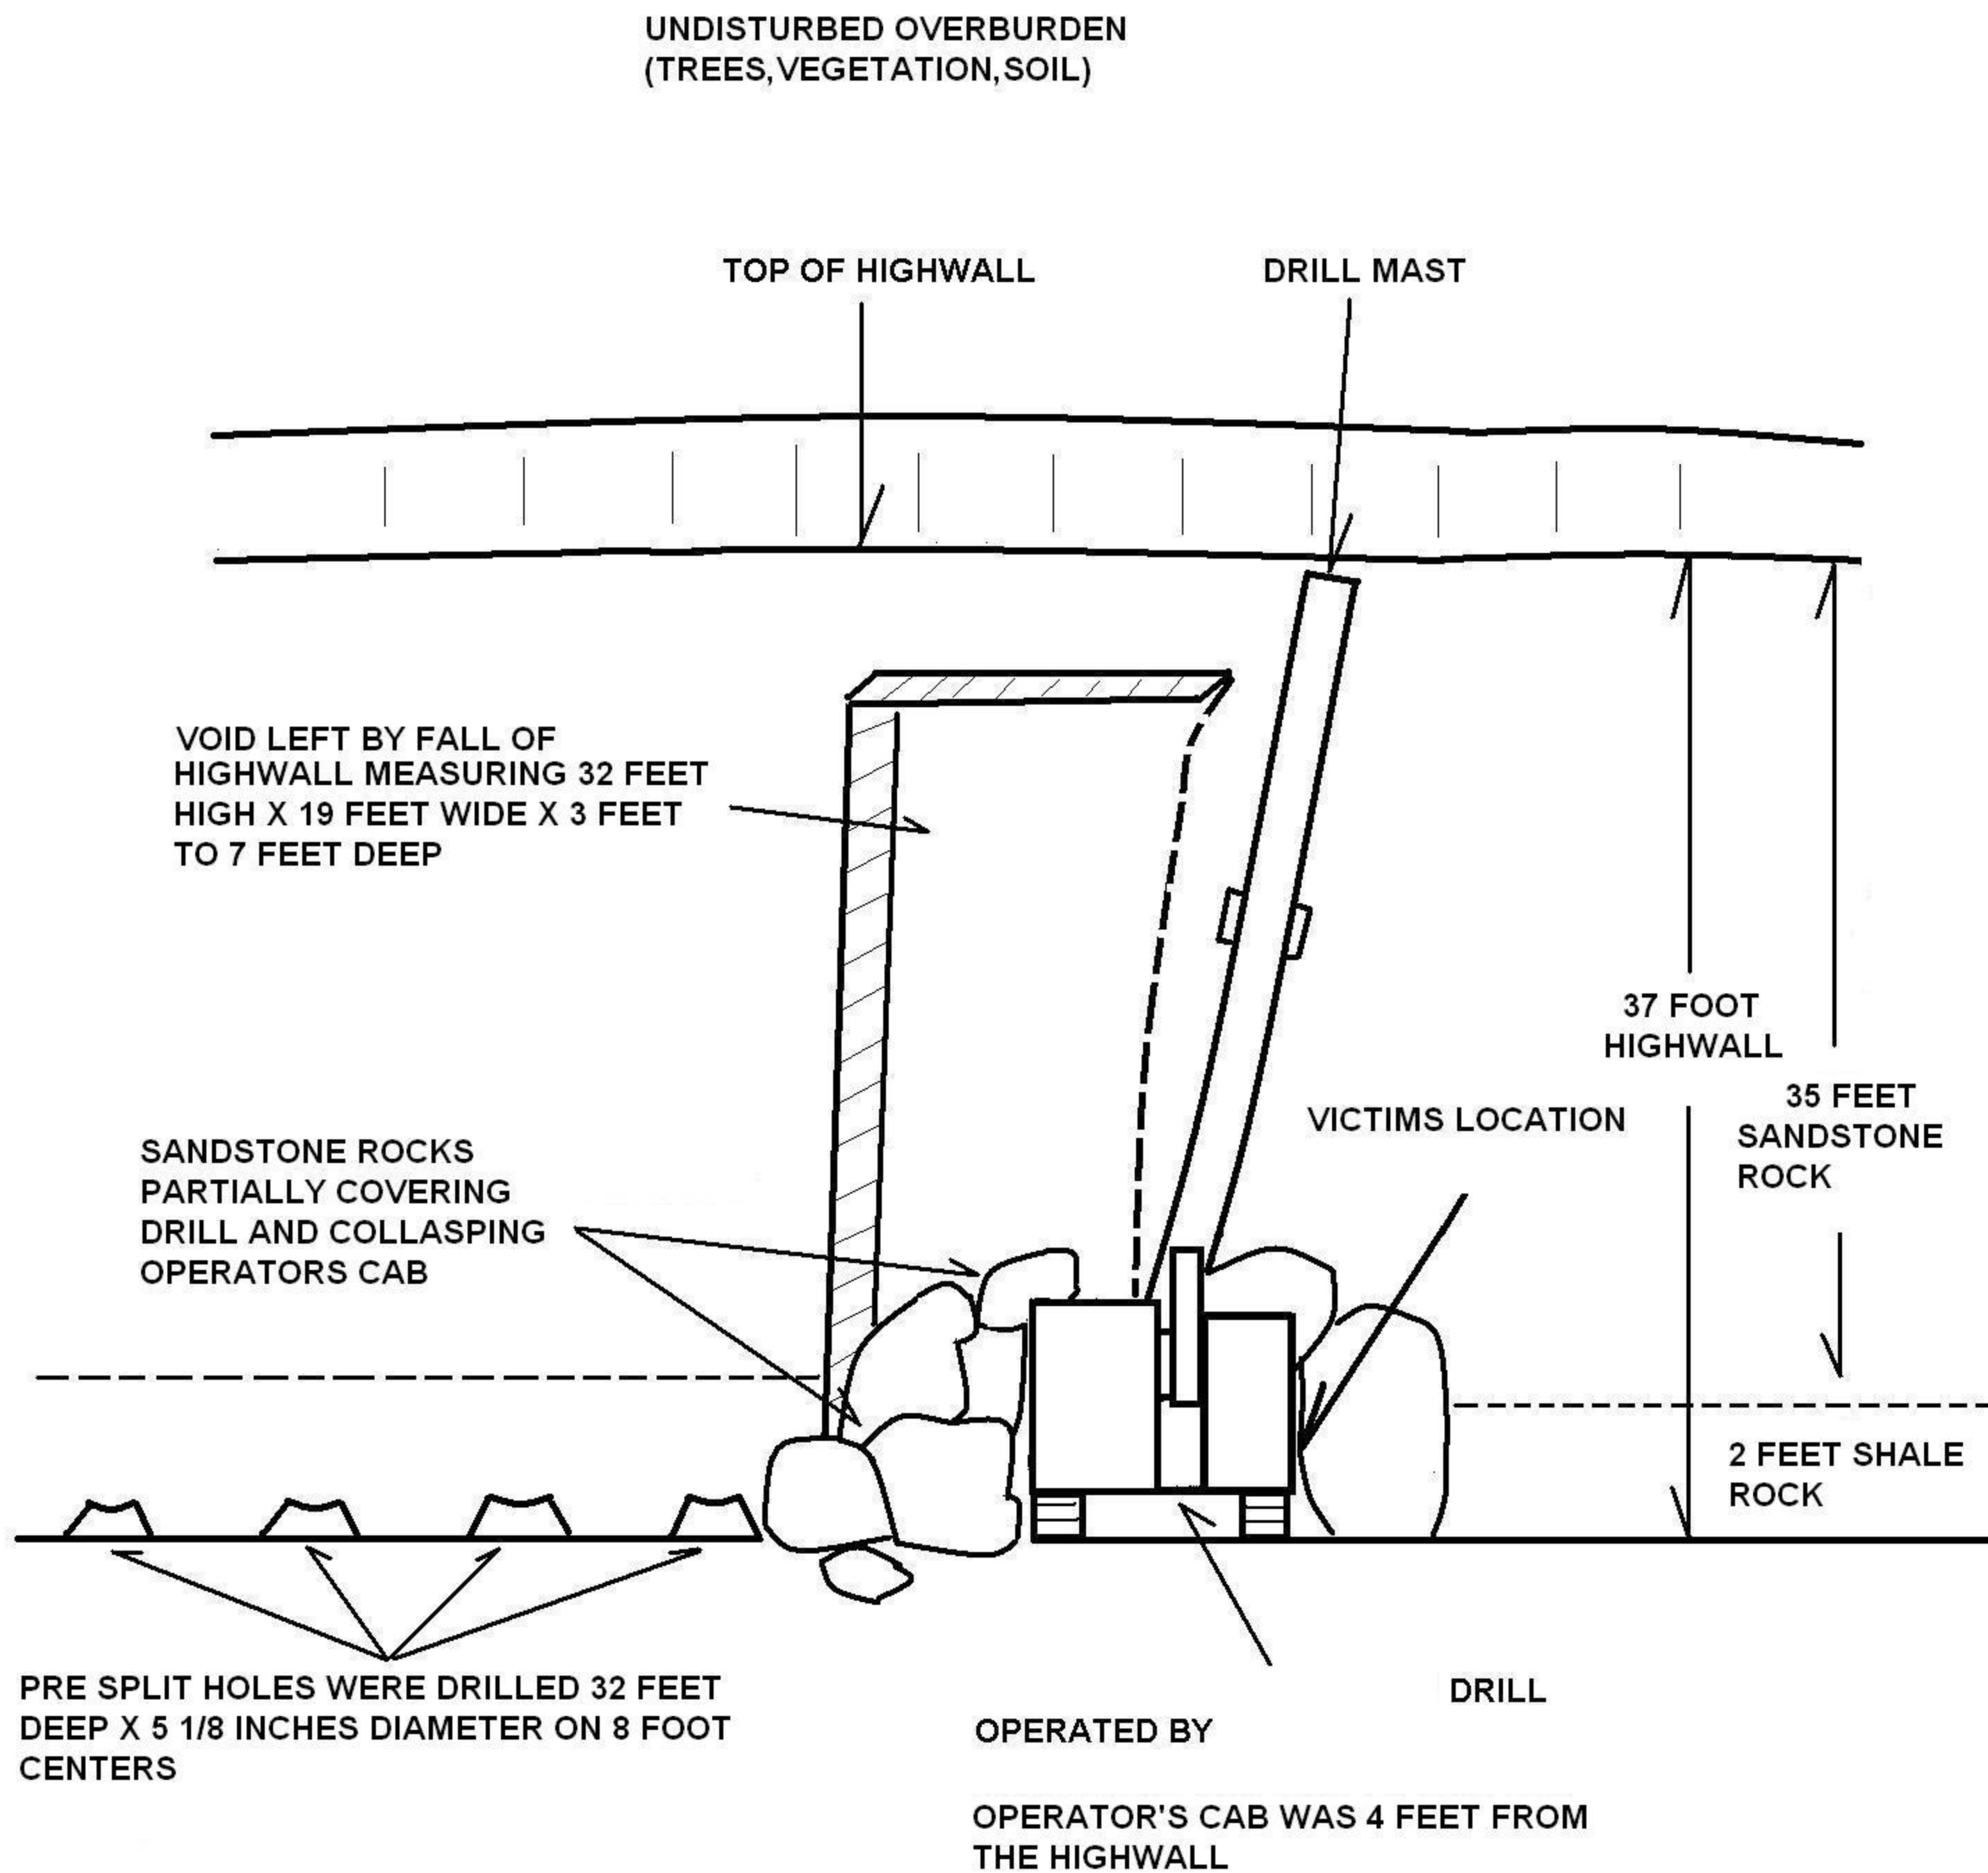
SKETCH NO. 2

The mine is a surface operation which employs a total of 10 employees on one production shift. The victim was in the process of drilling the first row of drill holes next to the highwall when a portion of the highwall collapsed. The collapsing material covered the 16 B Gardner Denver High Drill operator's compartment causing the compartment to collapse on the victim resulting in fatal injuries. The portion of highwall which failed measured 32 feet in height, 19 feet wide and 3 to 7 feet in thickness. The portion of highwall which collapse occurred along a hill seam that ran parallel to the highwall face.

AFTER ACCIDENT

1. Thorough examinations of the faces of highwalls shall be made by a competent person at the beginning of each shift, during the shift while men are working and especially after blasting.

2. Highwall drills used at or near the faces of highwalls should be equipped with a sufficient operations cab which would meet ROPS standards.
3. When parallel seams (mudseams) are encountered in the highwall face, precautions shall be taken not to expose employees to these areas.
4. When a highwall drill is drilling the first set of holes at or near the highwall face, equipment compartments shall be placed where the cab is always facing to the outside of the highwall.

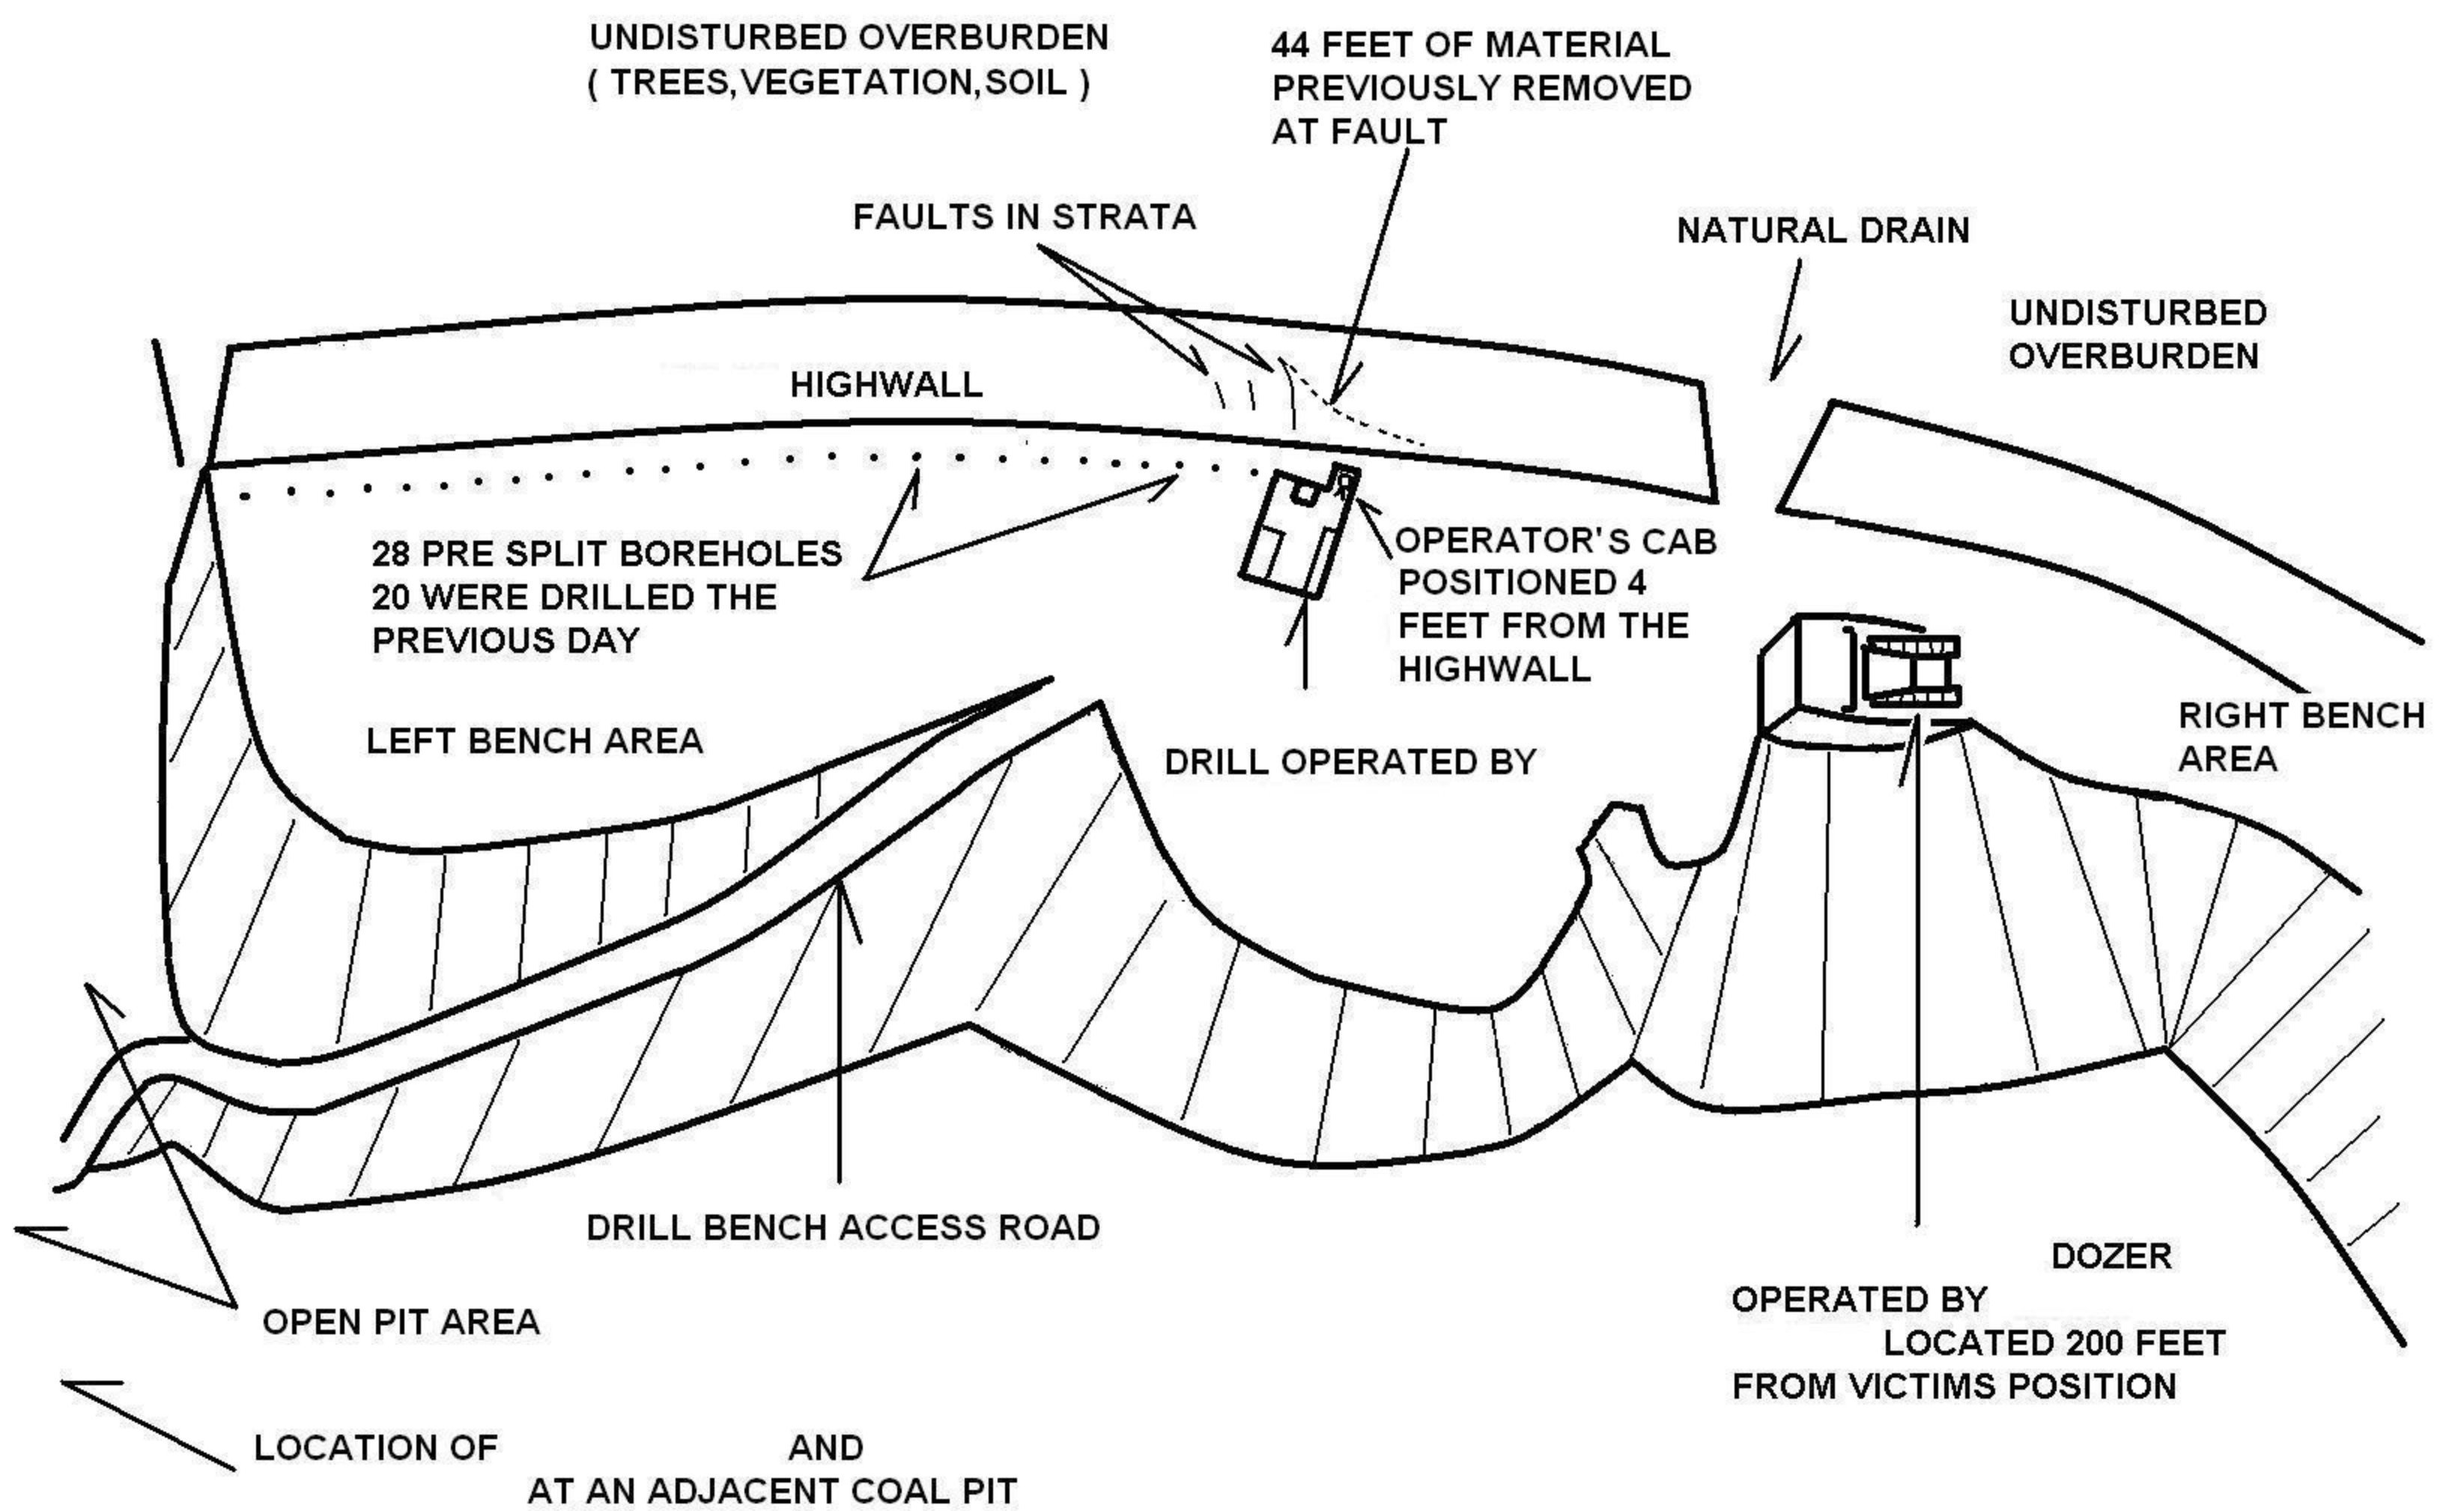
SKETCH NO. 1
PRIOR TO ACCIDENT
NOT TO SCALE

FOREMAN WAS
LOCATED NEAR THE MINE ENTRANCE
HELPING CONSTRUCT A SEDIMENT POND
